Fw 190D

Walk Around Number 10
squadron/signal publications

By E. Brown Ryle and Malcolm Laing

Focke-Wulf Fw 190D-9

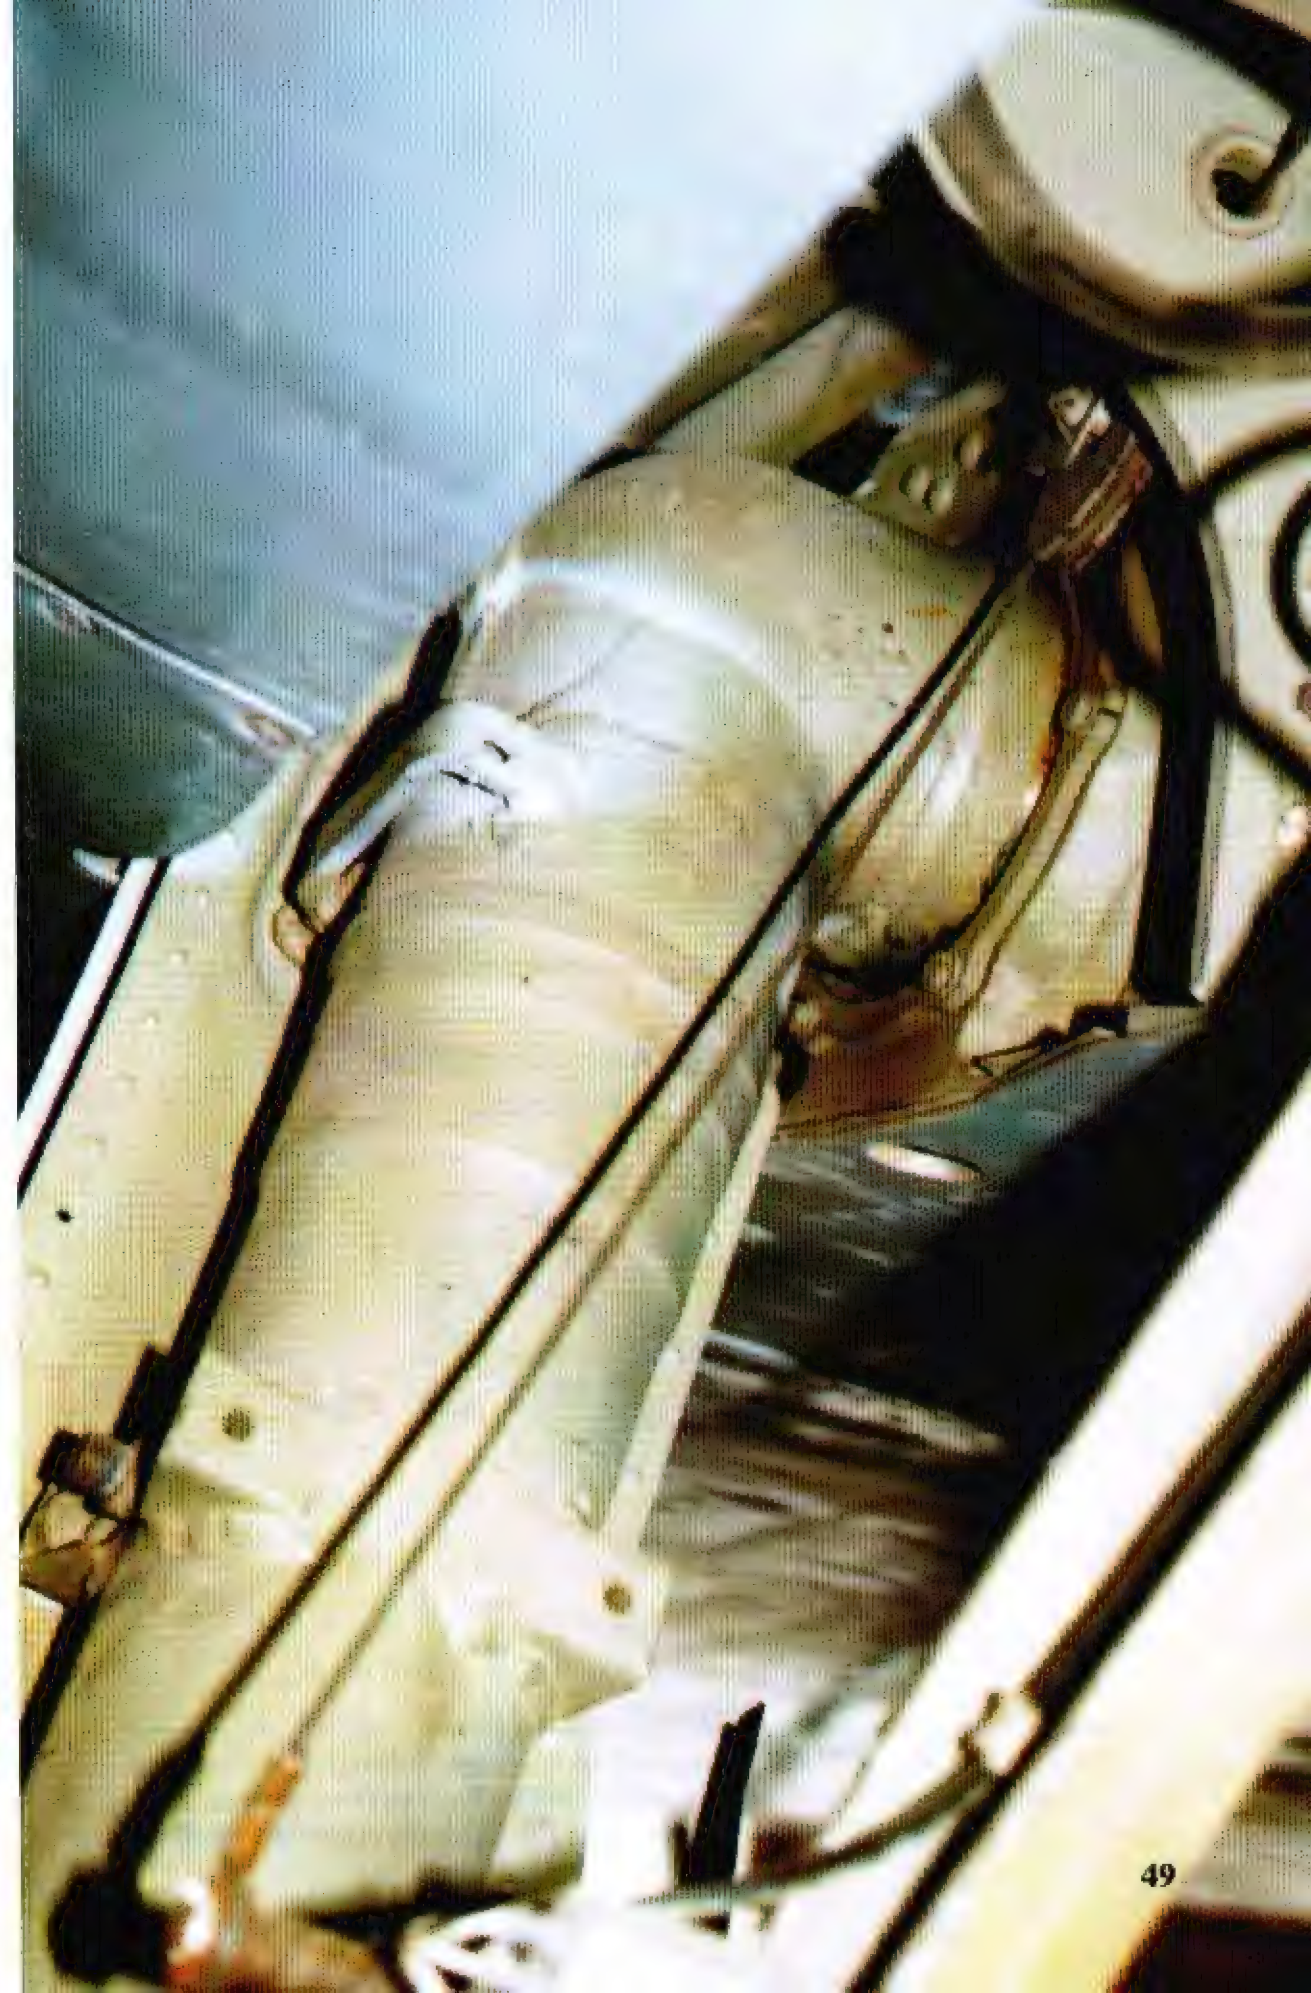
(Left) The stenciling on the (starboard) landing gear cover provides the proper main strut inflation for the take off weight. The small, round, darker blue areas are the cloth covers over the bolts securing the landing covers to the landing gear.

(Right) The upper joint of the starboard landing gear fits into the main spar by making a 90 degree bend toward the trailing edge of the wing. The wire attached to the upper extend/retract arm and the pulley in the corner of the wheel well is the tail wheel retract wire. This wire continues through the center of the wheel well to another pulley located beside the engine. (Author: Ryle)

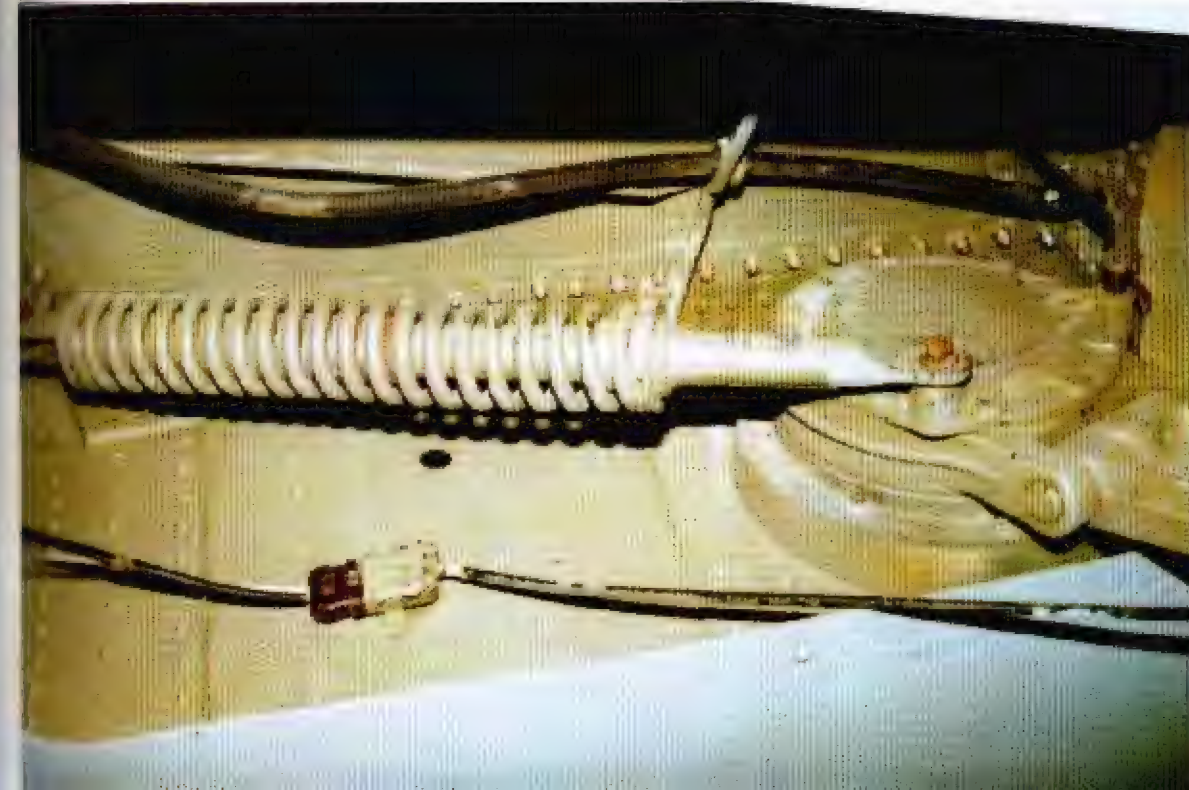
(Below) The port landing gear rotating drive unit mounted at the rear of the wheel well in the main wing spar. On the other side of the spar inside the wing is an electric motor used to raise and lower the landing gear. The spring covered rod is the 'sealed air jack' used along with the force of gravity to lower the gear if the electric motor was not available.

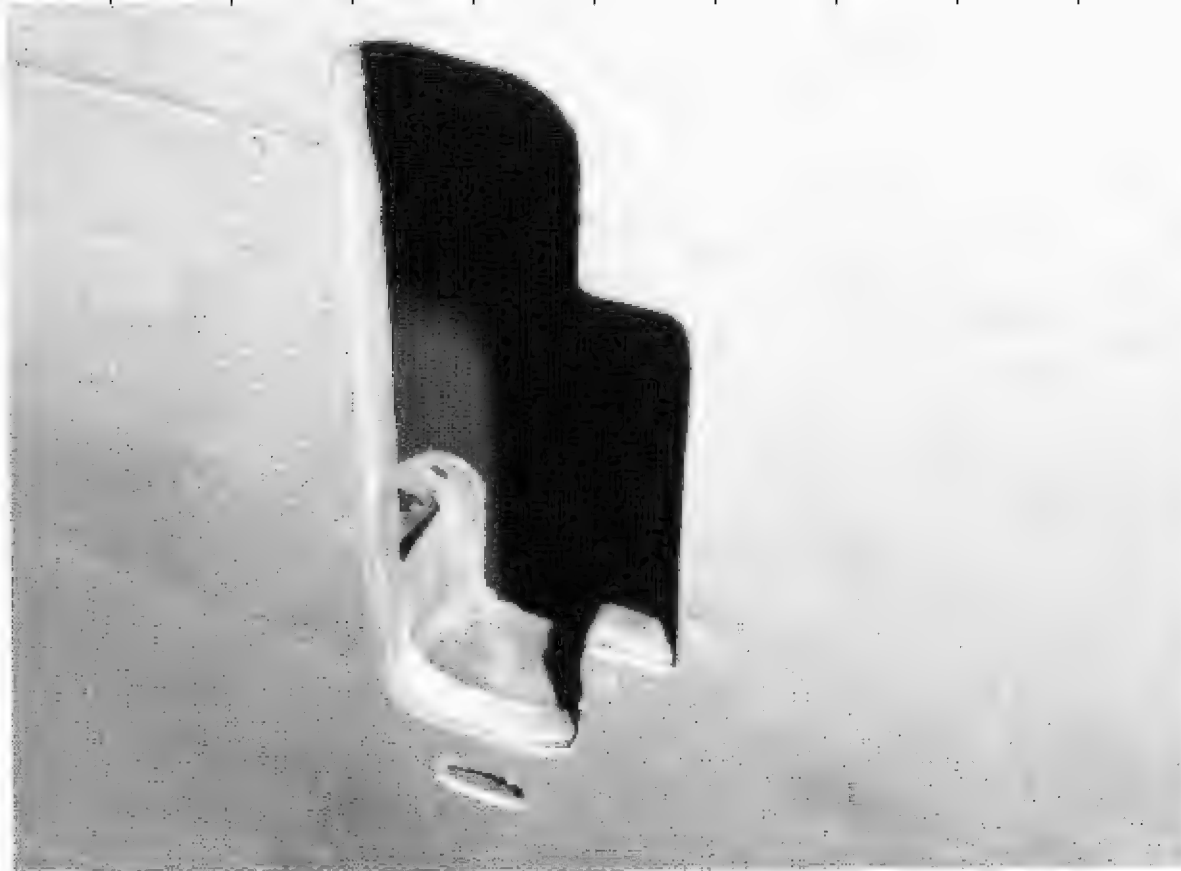
The disposal cartridge and link chute for the inboard wing mounted MG151 20mm cannon. The small hole aft of the chute opening was used to access the mounting screw for the internally fitted chute (which has been removed in this photo). (Author: Ryle)

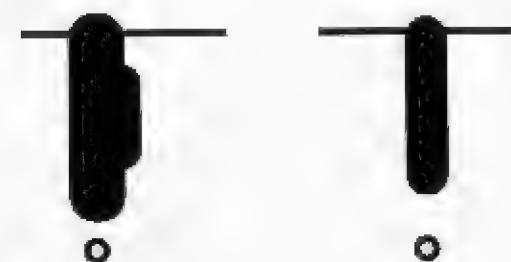
Wing Root 20mm Cannon Ejection Chutes

Early to Late
Production

Very Late
Production

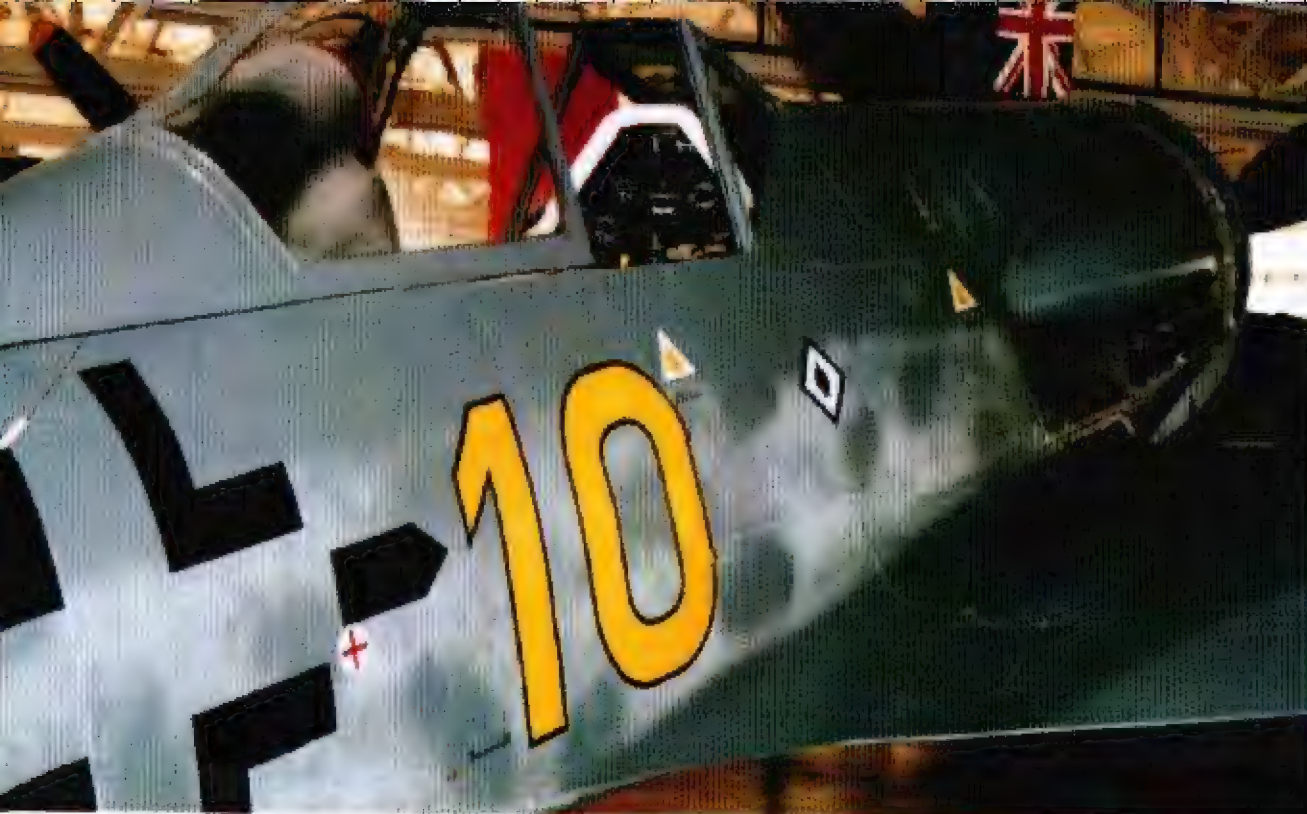
The red cross in a white circle identifies the medical stowage door. Through the open cockpit the instrument panel can be seen. The white padding around the instrument panel is non-standard, however, padding was installed in a darker color. (Author: Ryle)

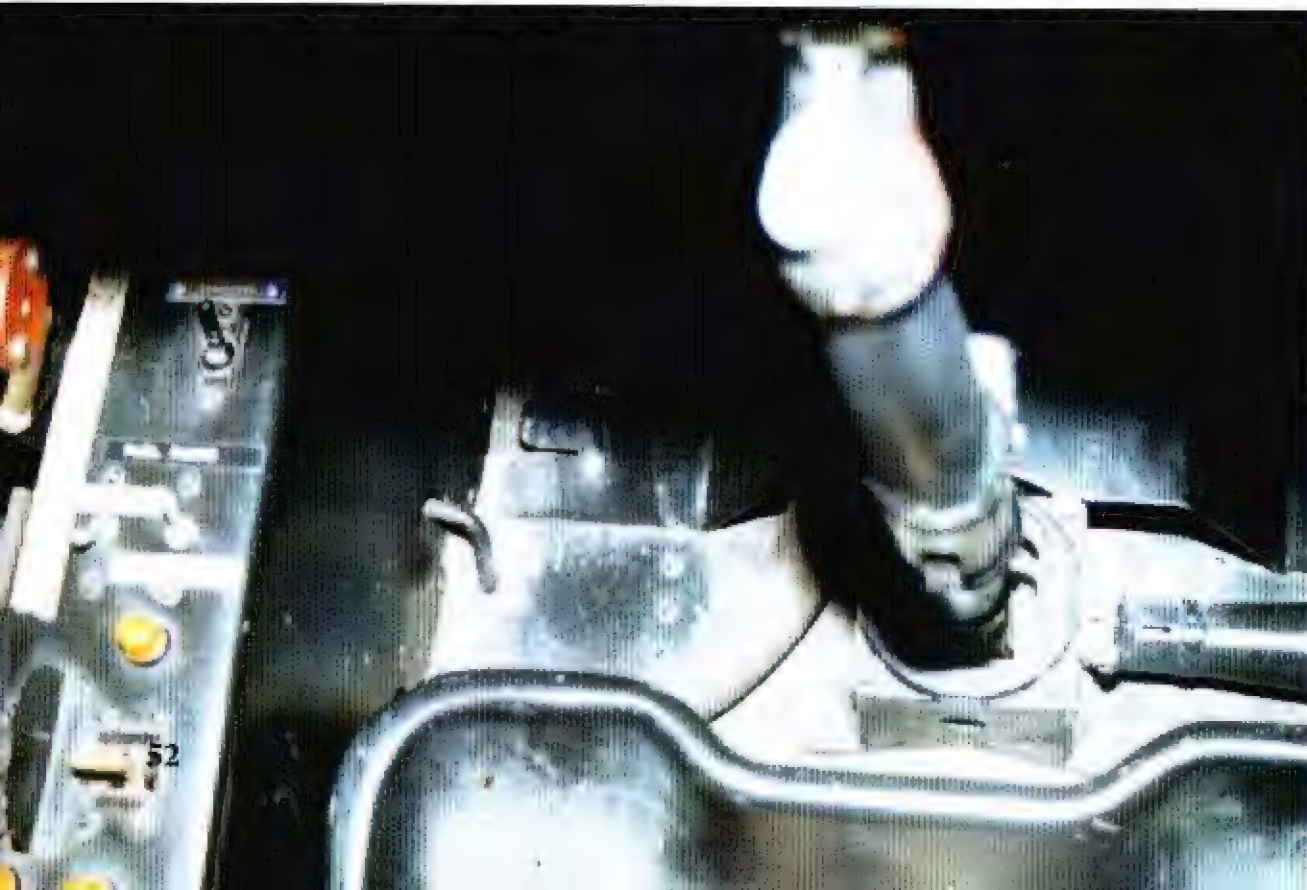
The control stick and its lower assembly, without the leather boot installed. The arm extending from the right side of the assembly (a replacement added during restoration), controls the elevators. On the bottom of the left side console is a small, bent rod which functioned as the throttle lever friction control. This was also added during restoration. Normally, a grooved, 2" diameter rod was used for this purpose. (Author: Ryle)

The left lower instrument panel is a replica with some original instruments installed. The KG13B stick grip with its data tag can be seen. (Author: Ryle)

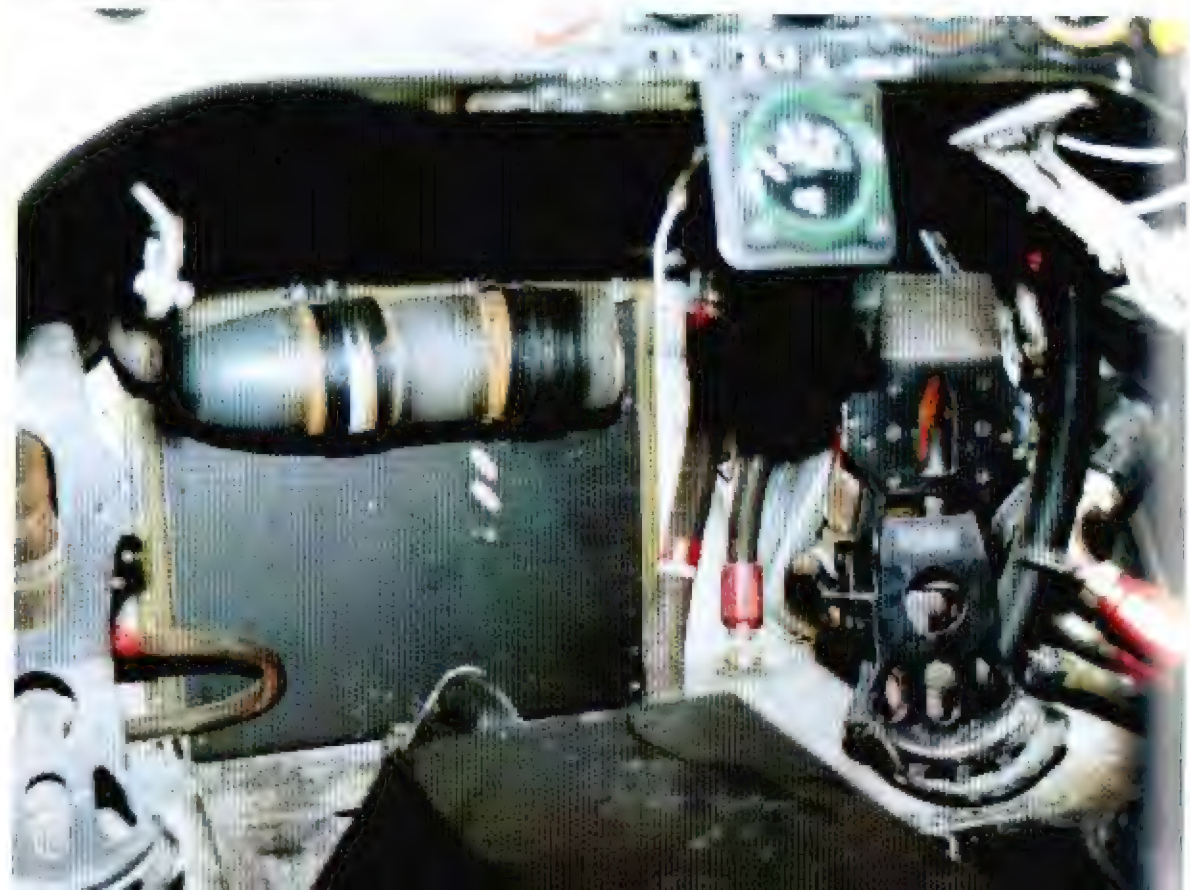
Two different styles of original rudder pedals are installed, which were usually installed like pairs, however with the continuous re-building of damaged machines this configuration could easily have happened. Behind the instrument vacuum flask is the fire wall with a Black metal plate covering the hole where the 20mm cannon's breech protruded into the cockpit. (Author: Ryle)

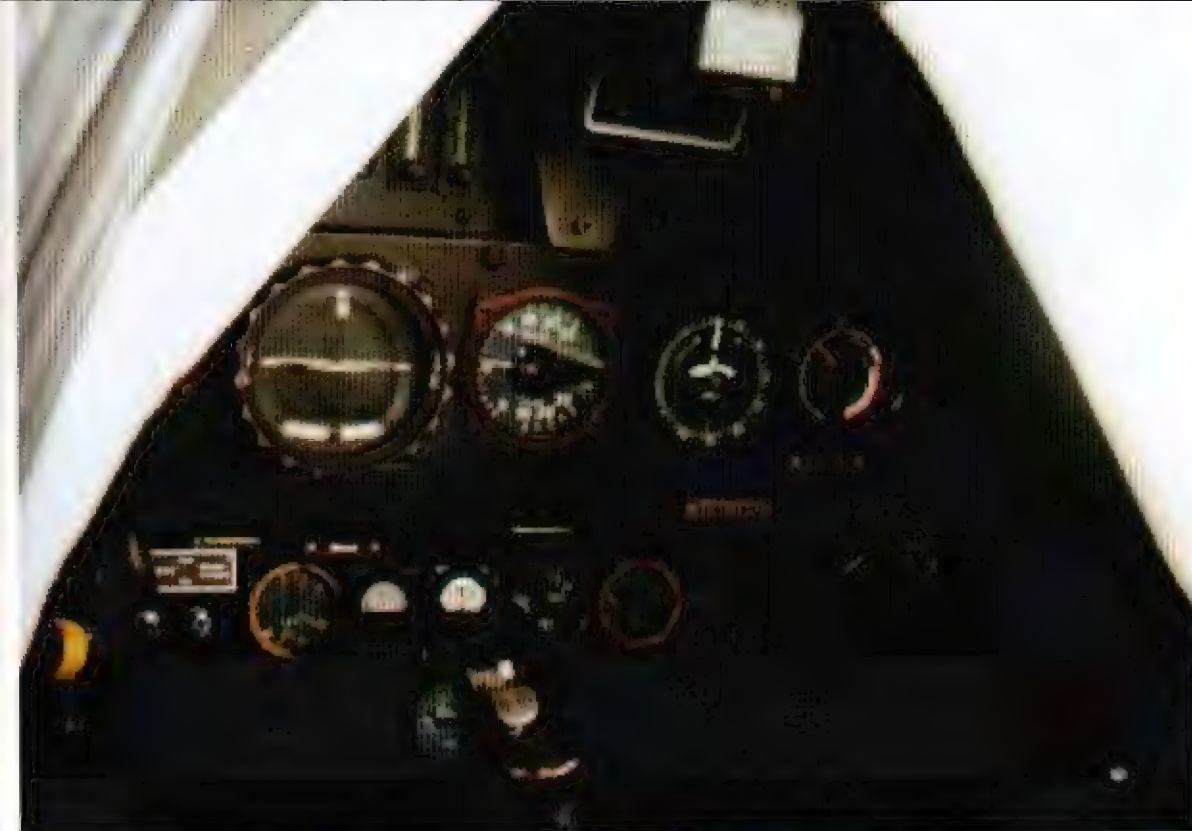
This instrument panel is not standard for an Fw 190D-9, but its configuration is within the variations seen on late war variant of the Fw 190D. The cockpit, including the instrument panel, would normally have been painted RLM 66 Black-Gray which is not as dark as the paint seen here. (Author: Ryle)

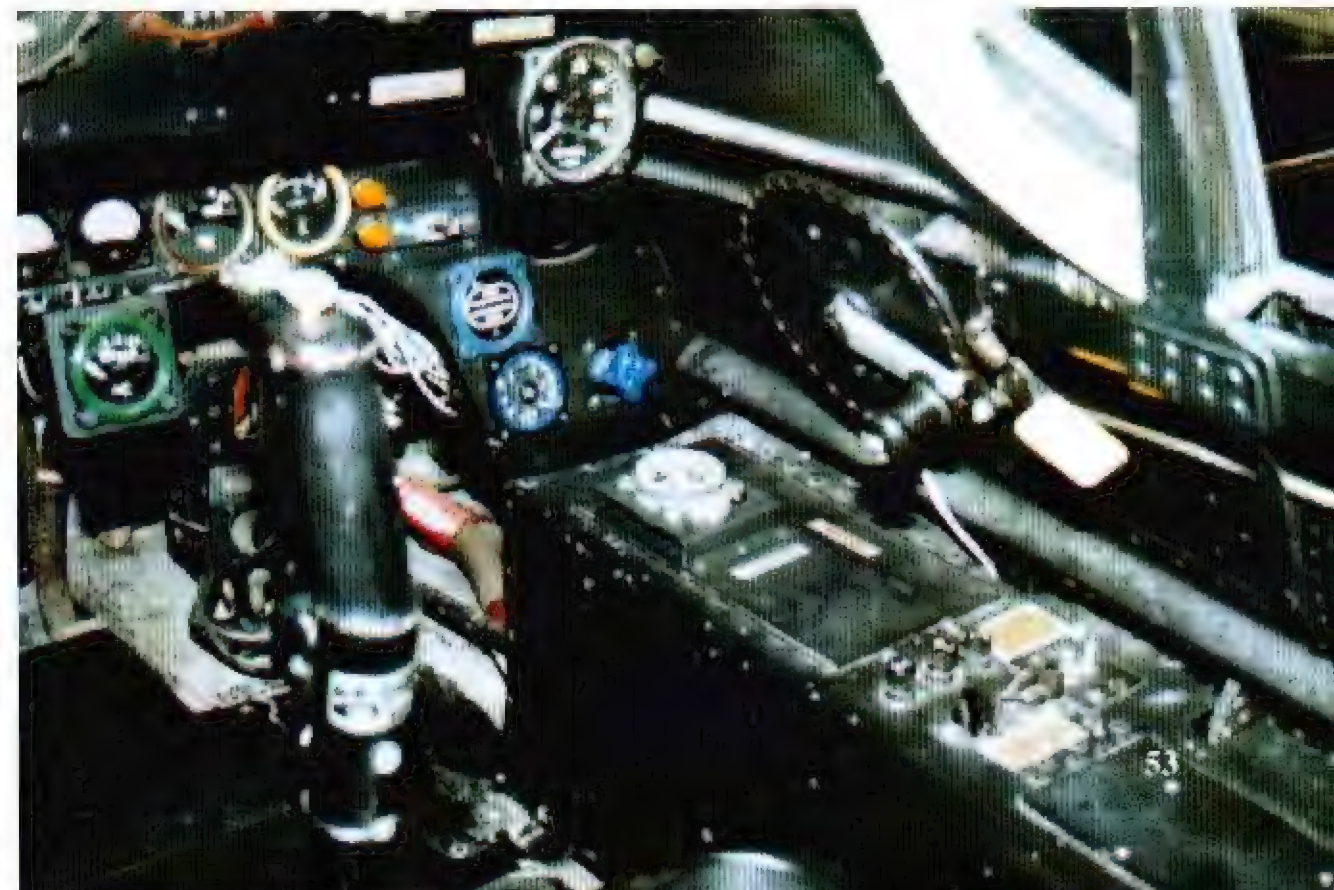
The right side of the replica lower panel. The only original part of the panel is the clock, which is located at the very front of the panel. The crank on the side wall is to open and close the canopy. The white square is the canopy eject lever, normally painted red. (Author: Ryle)

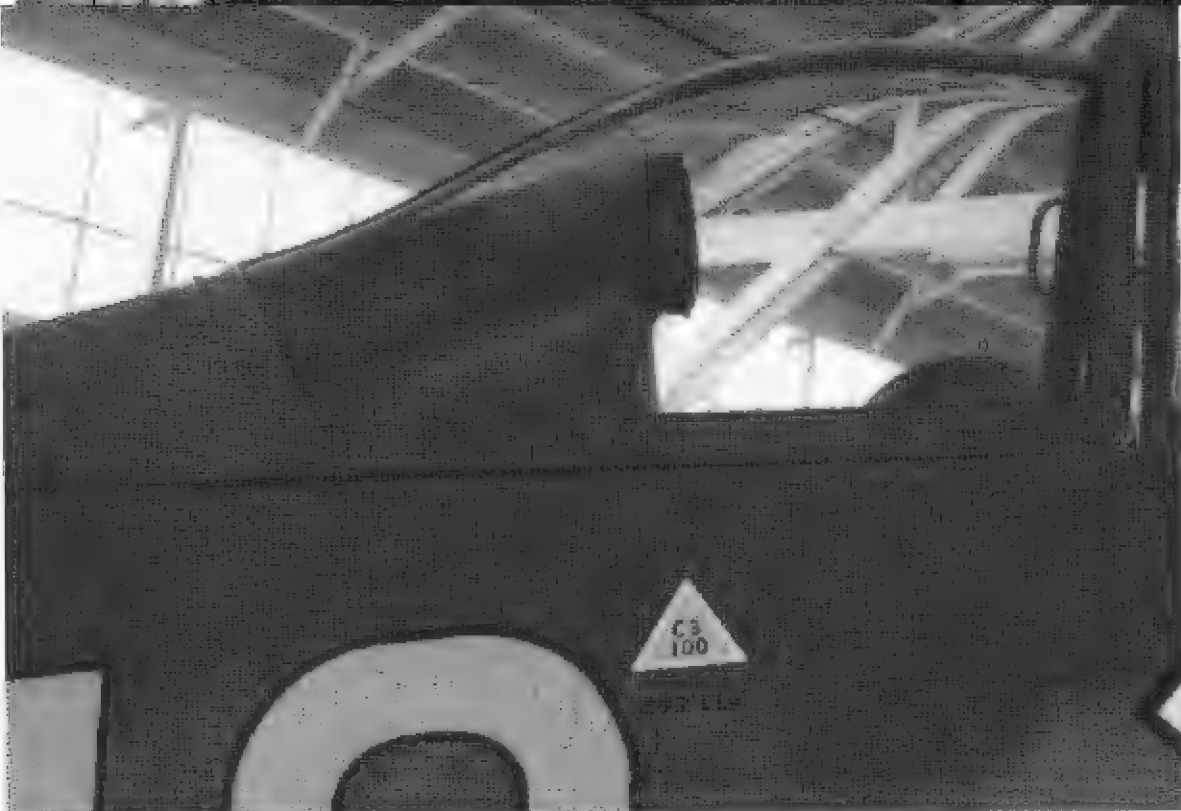
The general shape and of this two-piece replica 'blown hood' canopy and headrest is very close to the original. The antenna wire connects to the outside of the canopy above the headrest and does not enter the blown hood. The only entry of the antenna into the fuselage is the vertical wire's connection at the rear of the fuselage spine. (Author: Ryle)

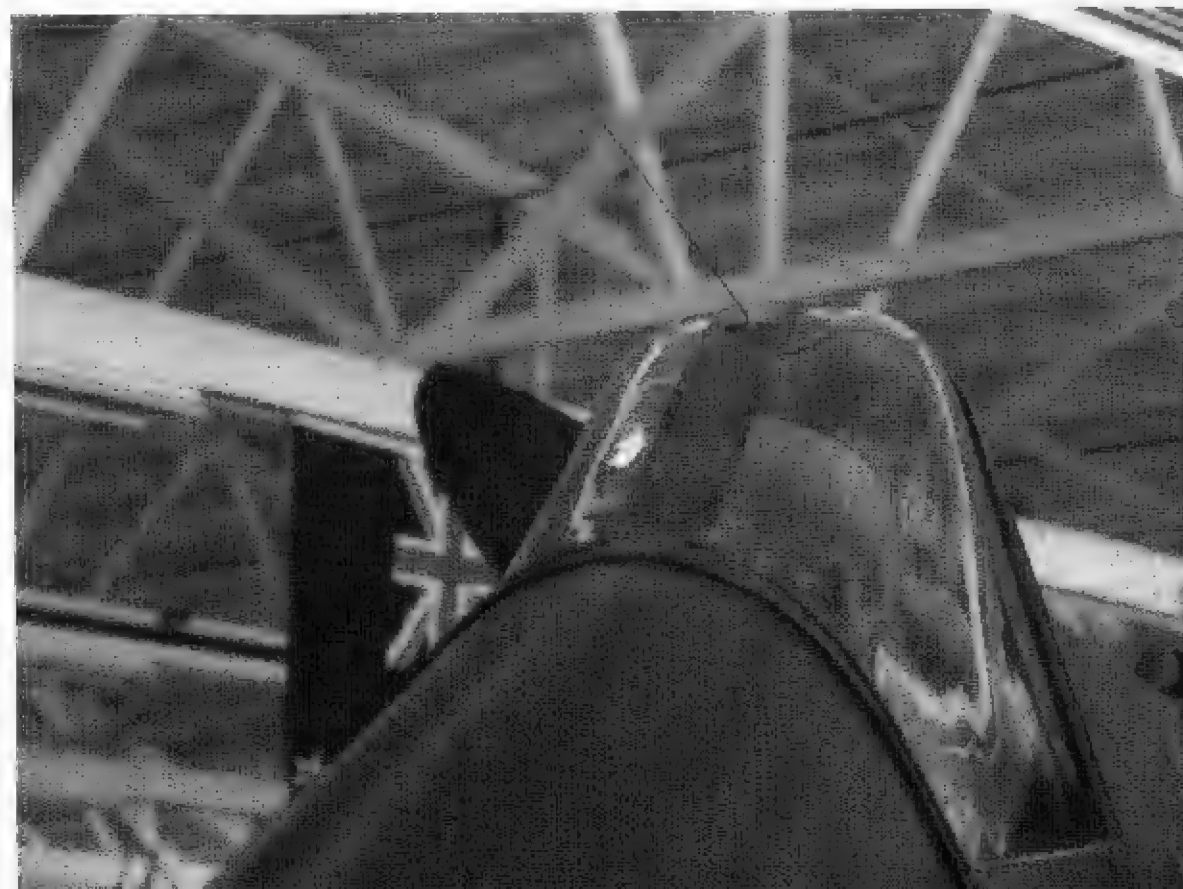
When the blown hood canopy is in the closed position the antenna wire is pulled taught. The original flat canopies were one piece clear Plexiglas with a hinge line cut into the forward, upper clear area. The two-piece 'Blown Hood' canopy was far easier to manufacture and repair than the earlier one piece flat hood. (Author: Ryle)

(Above and below) The connection of the vertical antenna wire that runs from the aircraft's spine to the main antenna wire running from the canopy to the top of the tail. Resistors are located on the main wire on either side of the vertical antenna wire. The wire is a correct bronze color. (Author: Ryle)

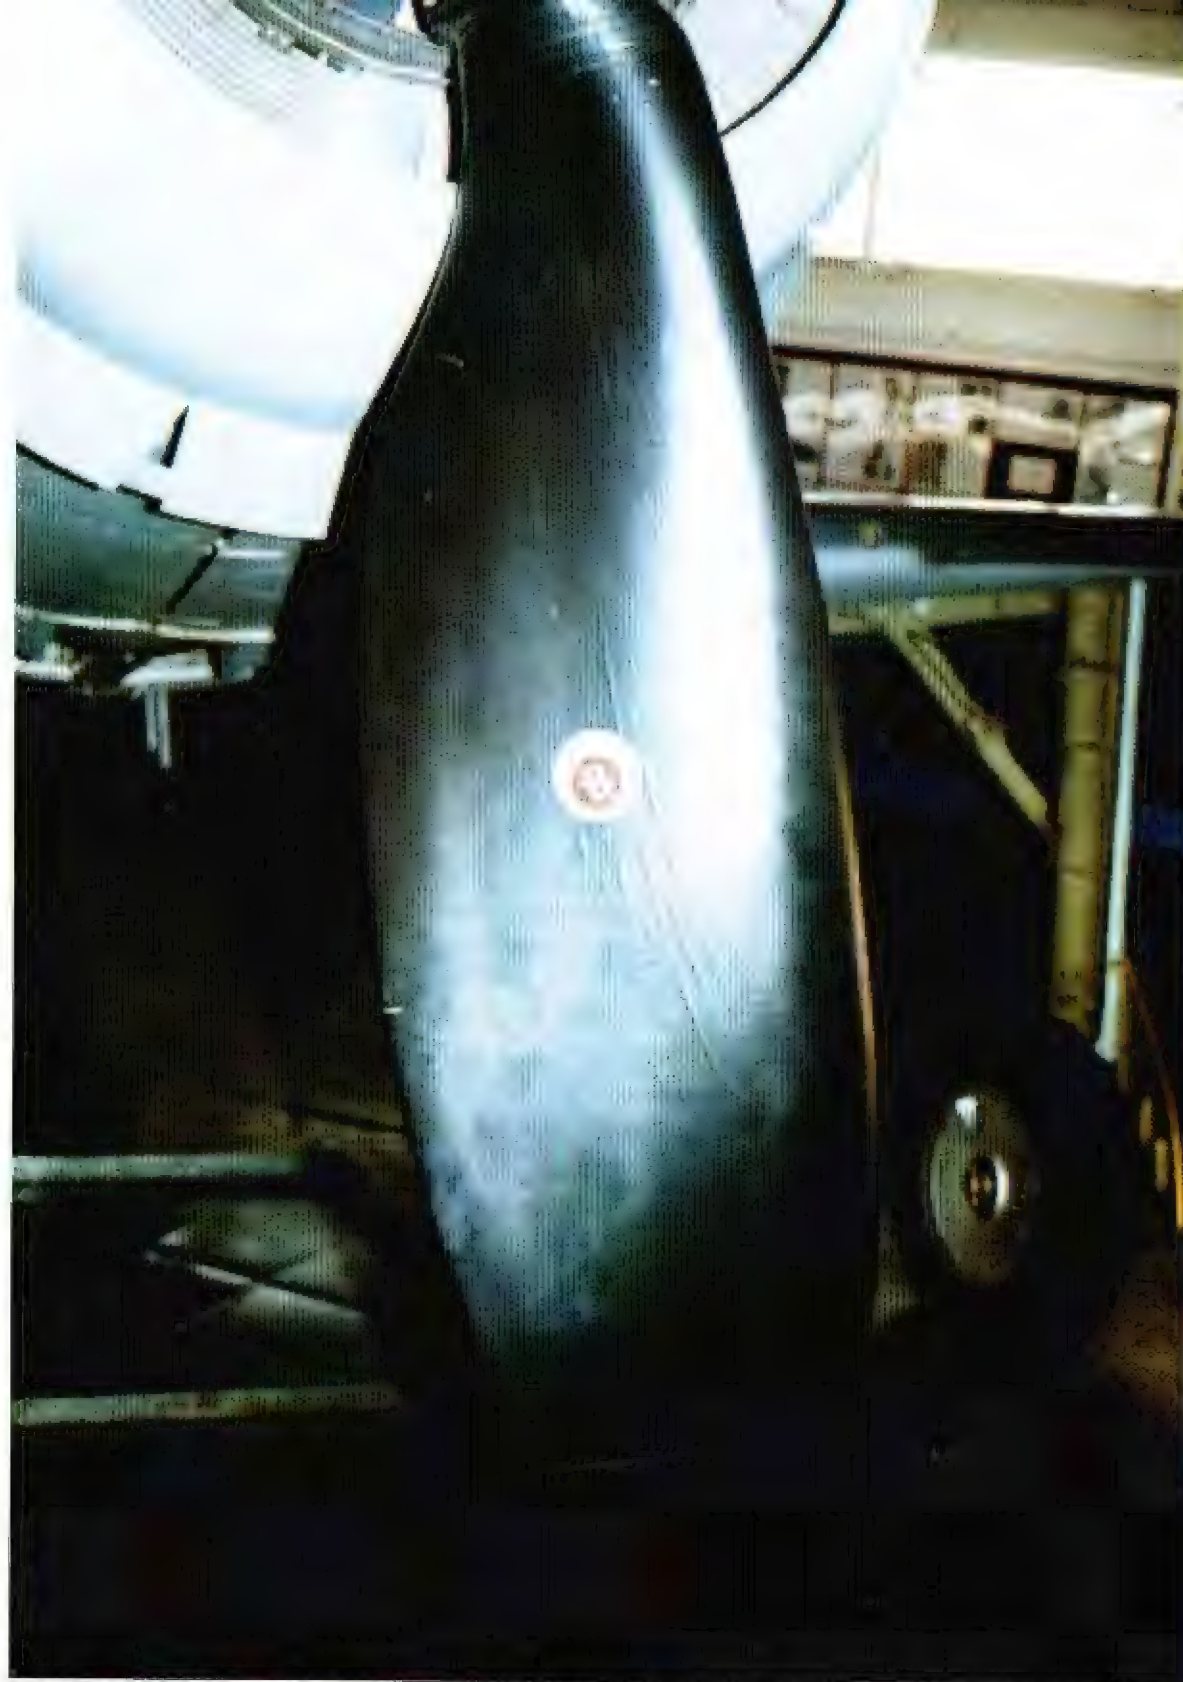
The Fw 190D-13 used a Junkers VS 10 variable pitch propeller. The blade seen here maybe original (but possibly not a VS 10), and if so, could have been made from one piece of hard wood with a metal leading edge and an exterior of painted cloth. The wrinkle lines on the blade are the result of the wooden blade shrinking inside its cloth cover. (Author: Ryle)

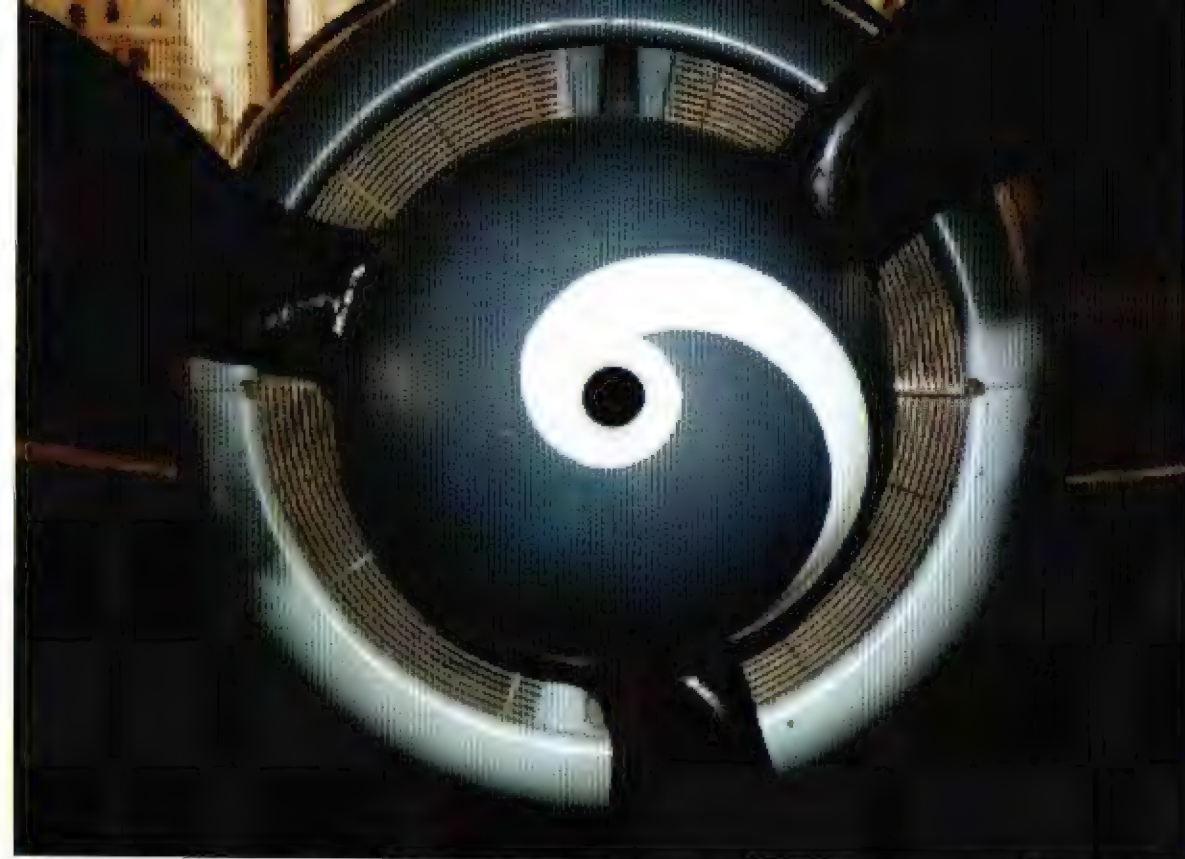
The hole in the center of the spinner is for the engine mounted 20mm cannon that fired through the propeller hub. The additional cannon provided the Fw 190D-13 with much needed firepower, but this arrangement gave problems and some aircraft are reported to have flown without the engine mounted cannon installed. (Author: Ryle)

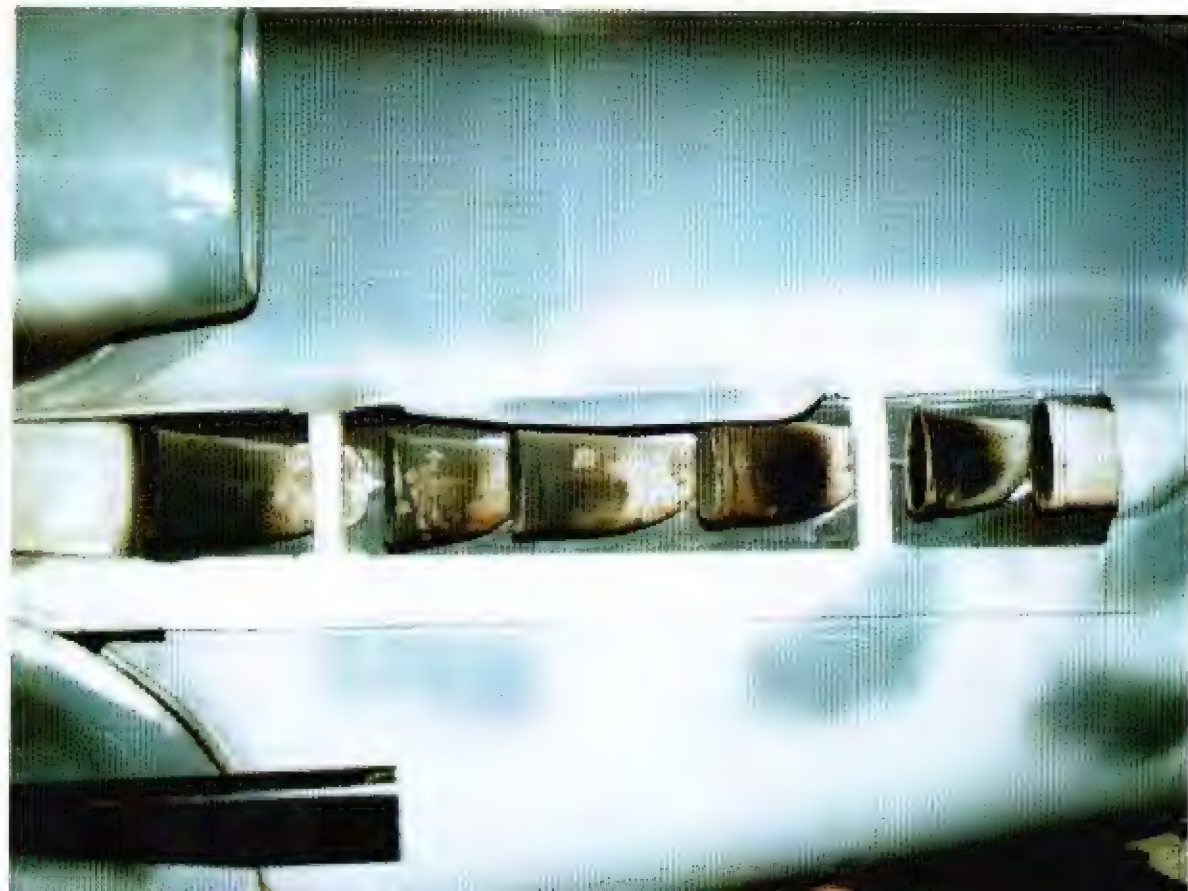
The first exhaust pipe is partially covered by an aerodynamic fairing and above the three exhausts in the center is a small fairing designed to keep the exhaust gases out of the supercharger air intake. (Author: Ryle)

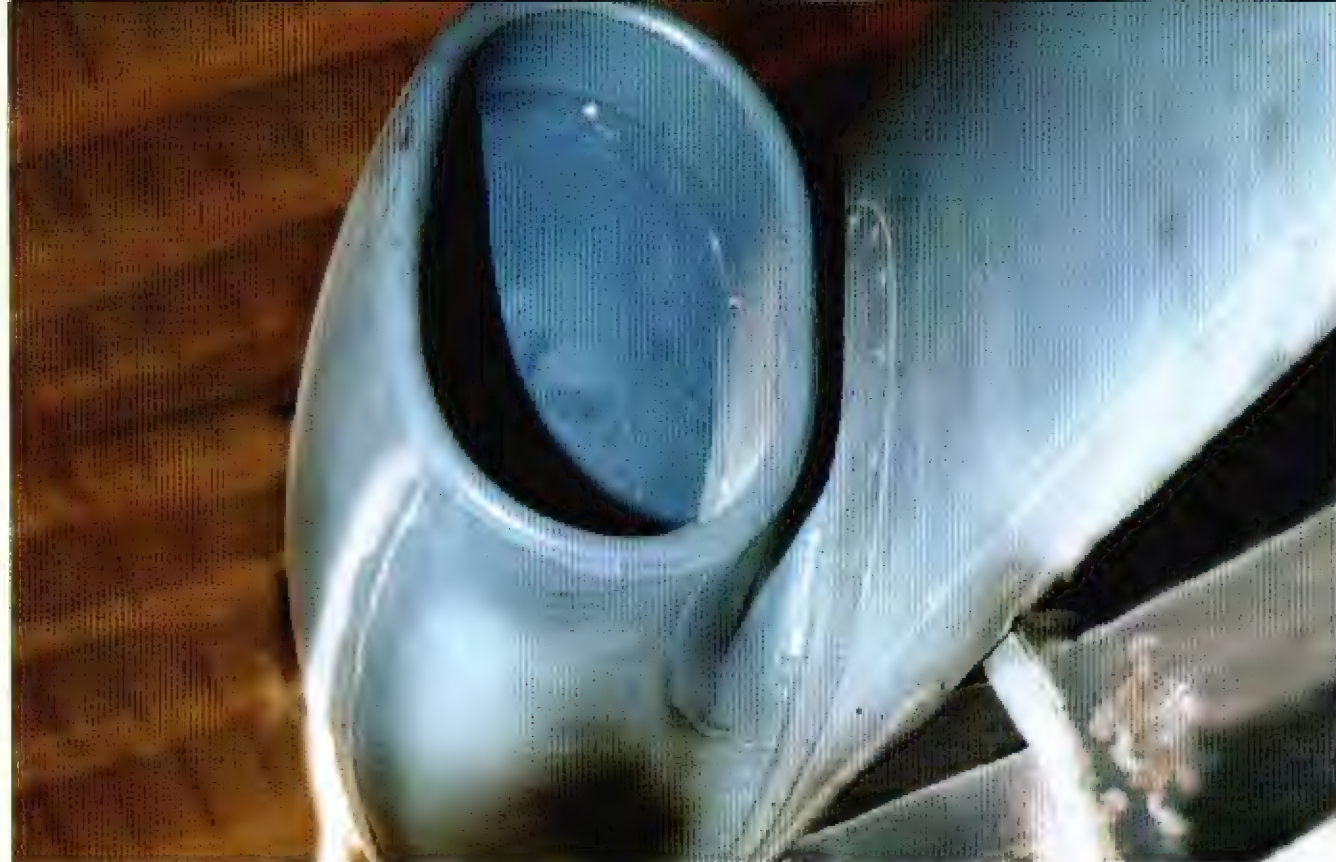
The spinner's back plate was attached to the spinner with a number of small screws. The opening for the radiator was quite small with a vast amount of the nose section being occupied by the large bulbous spinner. (Author: Ryle)

(Above and below) The size and shape of the later model intake found on the Fw 190D-11/12/13 and Ta 152 is much larger than the intake found on the earlier Fw 190D-9. The intake did not lie against the fuselage side and was made by welding together several component pieces. (Author: Ryle)

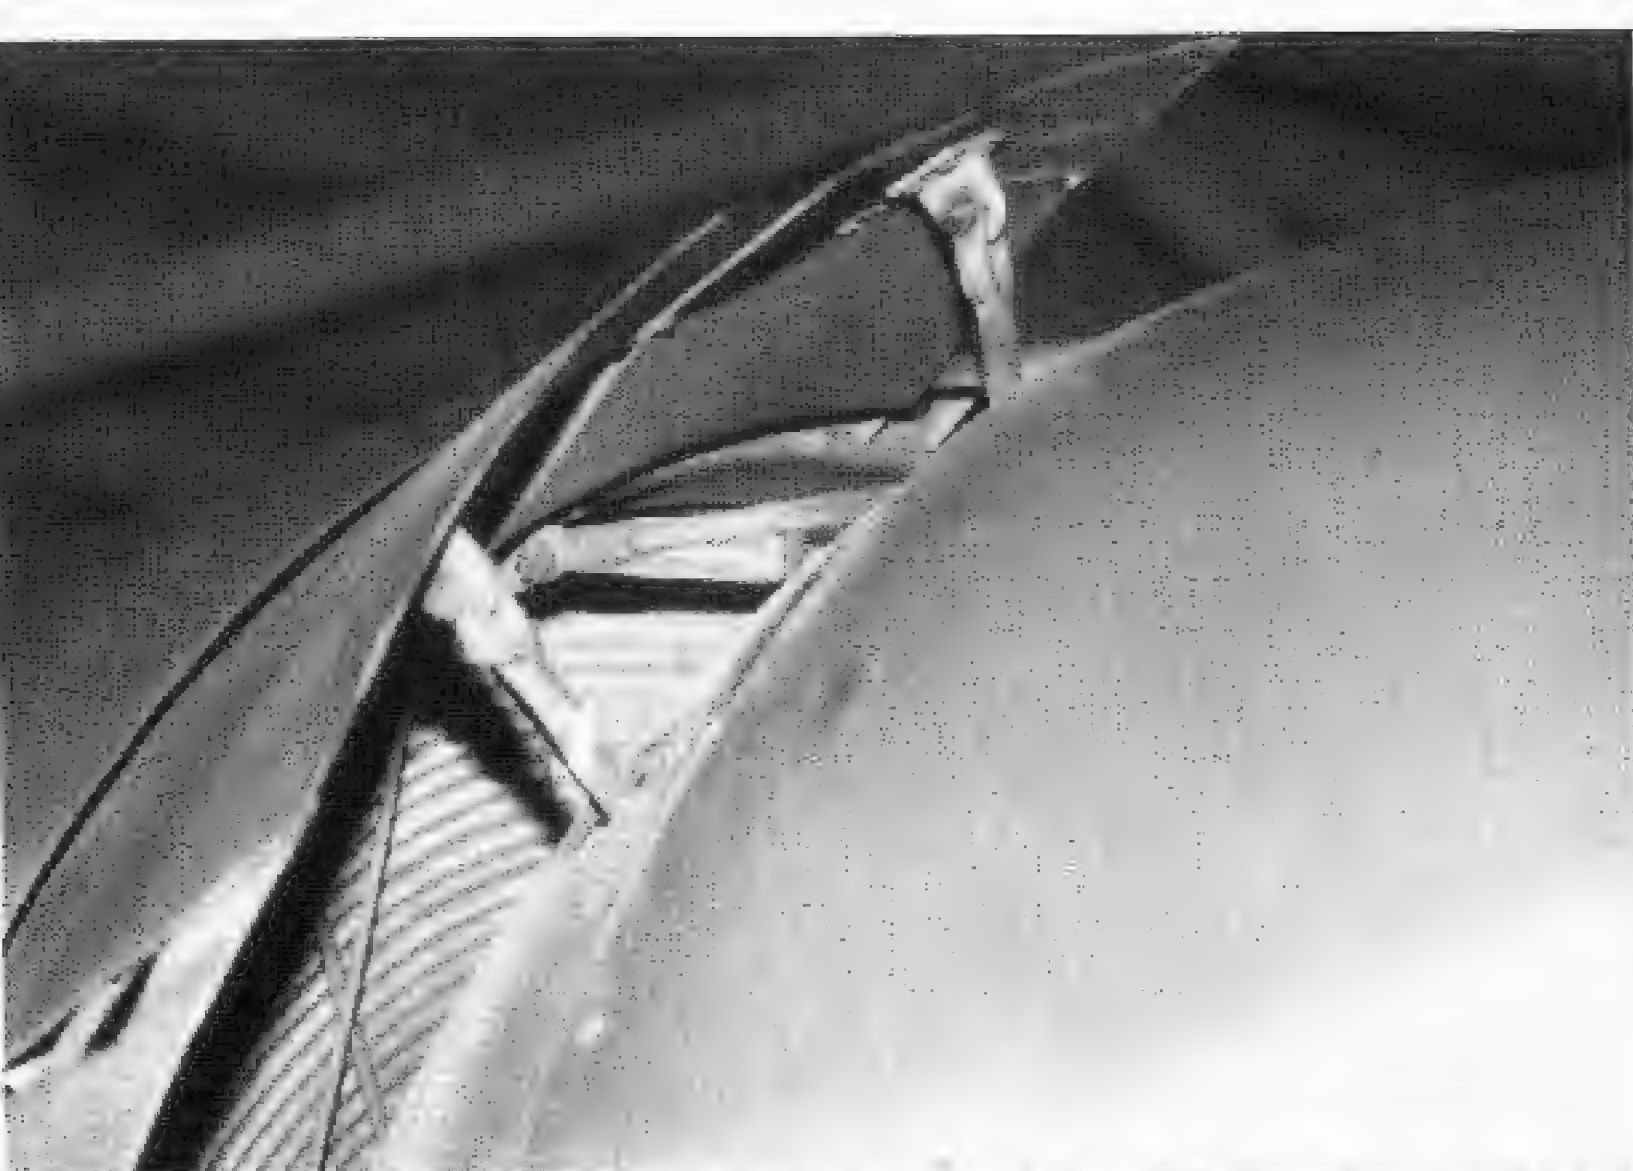
(Above) With the cowl flaps open the actuator rods pushing out the interconnected cowl-
ing flaps can be seen. (Author: Ryle)

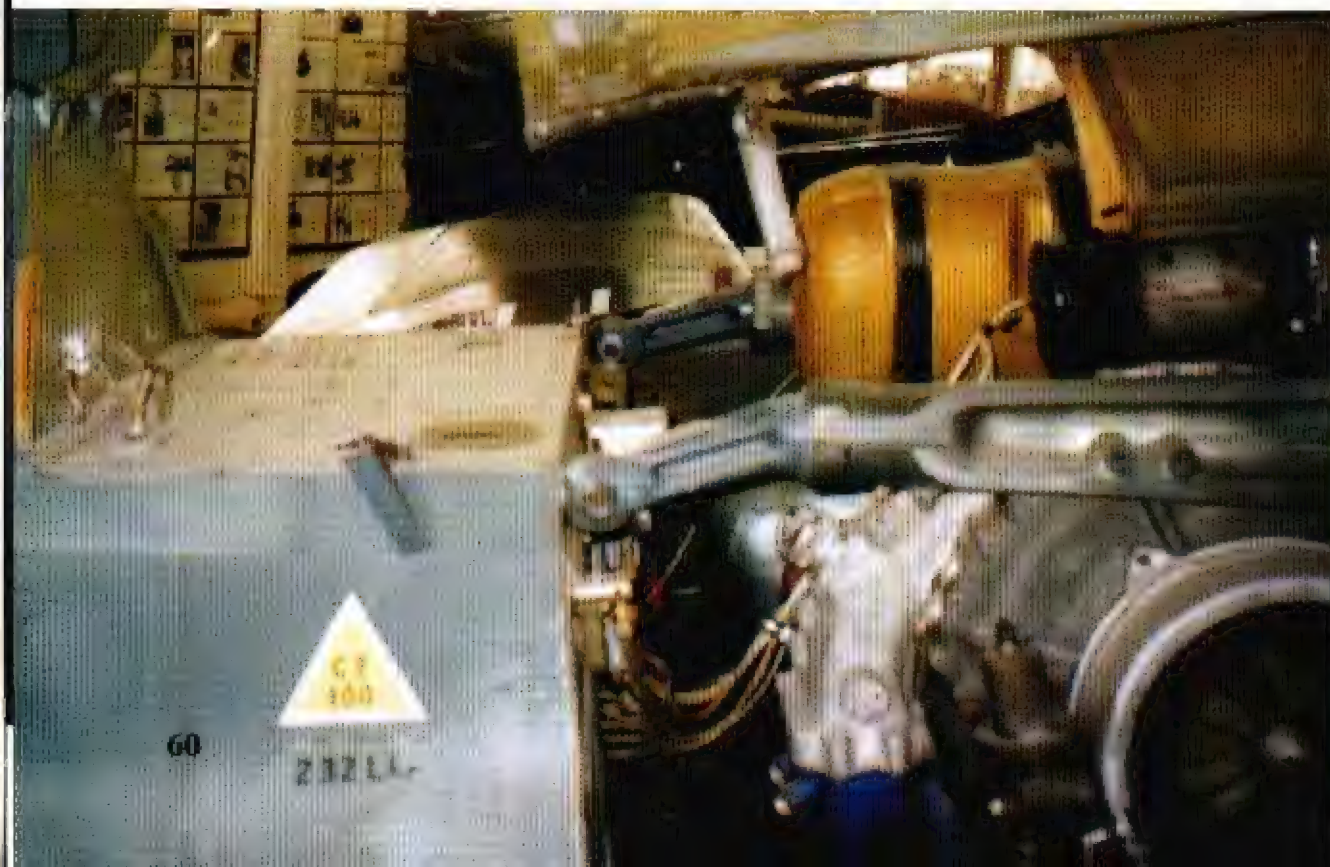
(Right) Looking directly down into the rear of the engine compartment at the fire wall. The upper engine bearer link bends slightly outward to attach to the fuselage brackets. The taped over pilot's air intake is on the fire wall to the left of the silver supercharger which has the generator partially overlapping it. Just above the pilot's air intake on the fire wall is the silver box containing the ignition relay. The yellow coolant tank is just above the silver oil tank. The starboard engine bearer curves slightly outward to meet the fuselage attachment. (Author: Laing via Goss)
